CORRECTION

WIRING DIAGRAM OF AN AMPLIFIER FOR DIFFERENTIAL THERMAL ANALYSIS

CARL W. BECK, *University of New Mexico, Albuquerque, New Mexico.*

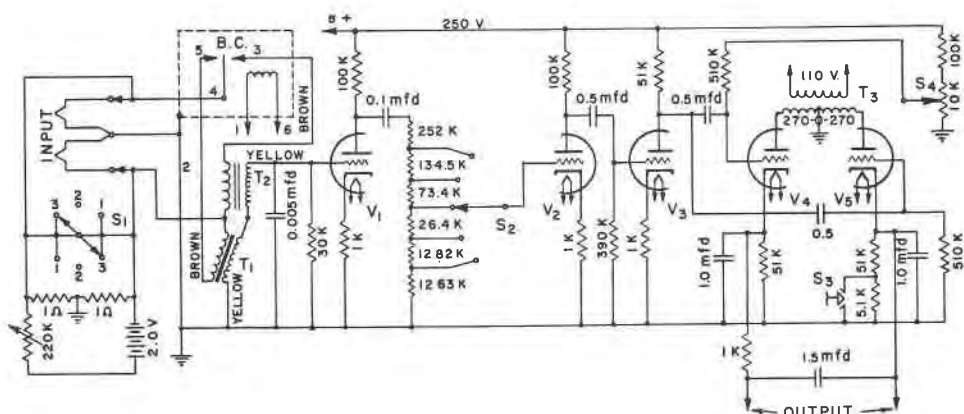
FIG. 2. Schematic diagram of amplifier.

Attention has been called to two drafting errors in Figure 2, p. 509, *Am. Mineral.*, Vol. 35. (1) The wire coming from S_4 should not connect to the 250V line—if the S_4 were turned down to the ground end it would short out the power supply. (2) The grid on tube V_5 is grounded—this is corrected by adding a 510K grid leak. Both of these errors have been corrected on the wiring diagram below.

B. C. = Brown Converter
 S_1 = Calibration Switch
 S_2 = Sensitivity Switch
 S_3 = Temperature Indicator Switch
 S_4 = Centering Switch
 V_1, V_2 = 6SL7

V_3 = $\frac{1}{2}$ 6SN7
 V_4, V_5 = 6SN7
 T_1, T_2 = Thordarson T-72A59 Transceiver Transformer
 T_3 = Acme B-4 Transformer, 110 V to 270-0-270
